## Renovation of the Seal Station on Gålö 2016-2018

### Report

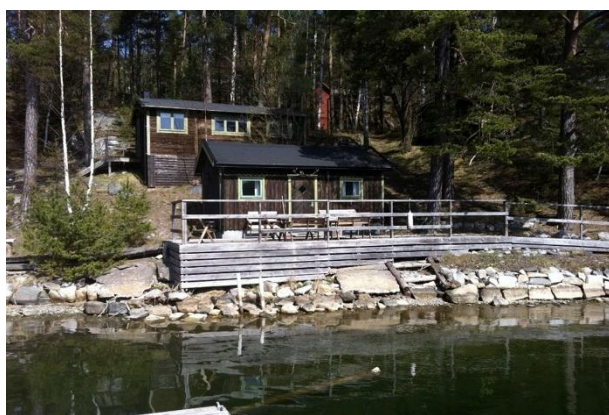
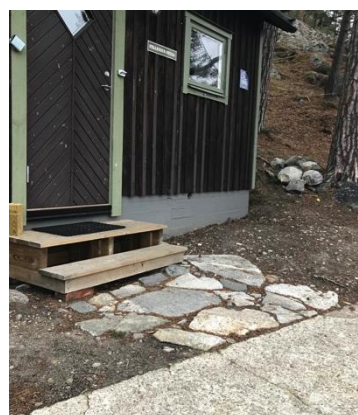
At some point after the military experiment was discontinued, a wooden terrace was constructed in front of one of the remaining buildings. To restore the 1940s exterior, the terrace was demolished along with the wooden walkways between the jetties. Below the planks we found concrete paths from the original seal station, which we carefully restored.

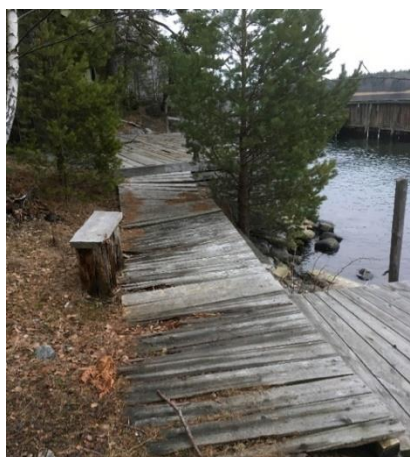
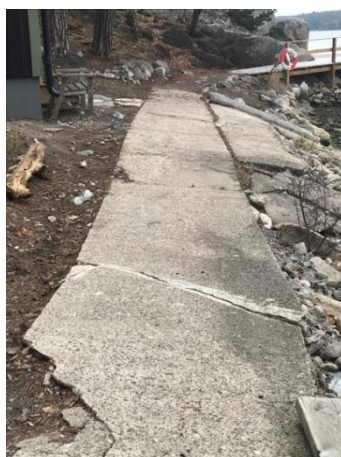
In the spring of 2017, marine archaeologists from Södertörn College completed a marine archaeological examination and a survey with a metal detector. They made an exciting find in front of the house by the water: beneath the soil and rubbish, they

discovered a beautifully laid stone path. And under one of the stones, they found a coin from 1943 – a little greeting from the people who laid the stones. This stone path has, of course, been preserved.

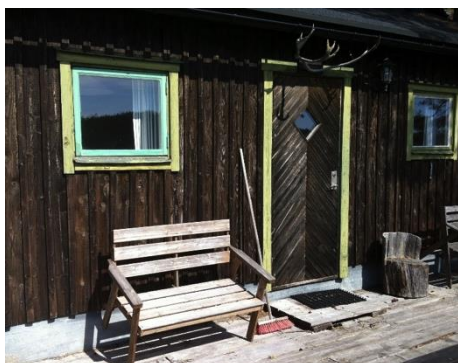
The programme of experiments involving the seals was classified as top secret by the Swedish military. So as not to reveal what was actually going on, the kitchen and the camp buildings for the personnel were built to resemble sports cabins. Of all the original buildings, two remain. The building closest to the water was a kitchen in the 1940s, but over the years it has been converted into overnight accommodation.

According to the building historian, the exterior had remained relatively unchanged, however, although in need of some renovation. The façade was coated with “Roslagsmahogny”, which is a kind of tar-based treatment. The window and foot panels had previously been painted and repainted several times and in different colours. The historian managed to uncover the colour of the bottom layer, and was also able to determine the colour code. We presumed that this was the original colour and used it in the repainting work.

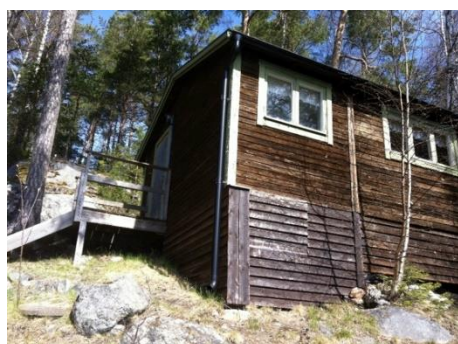
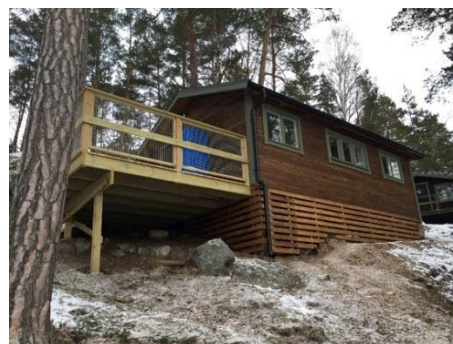
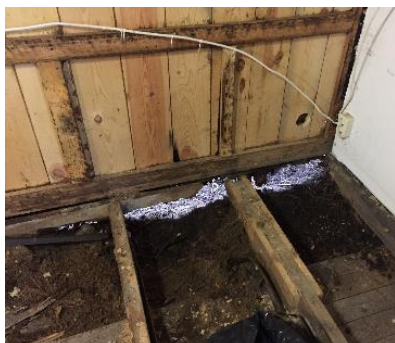
The other building remaining from the original experimental station is the one that is used as the kitchen and canteen today. When it was built back in 1941, it was used as a camp building for the personnel. It has probably had an extension added since, given that the southern section – the kitchen today – is clearly built using different techniques to the larger, original part. An examination of the original façade also indicates that the building has been extended. When the renovation work began, there was a strong odour of decaying wood in the building, and to establish where it was coming from, we tore down the interior walls and ceiling. We discovered that the framework that the building stands on had rotted, as had a section of the exterior walls. The roof had been built of

extremely frail wood, using a defective construction; there was no ridge beam, for example.

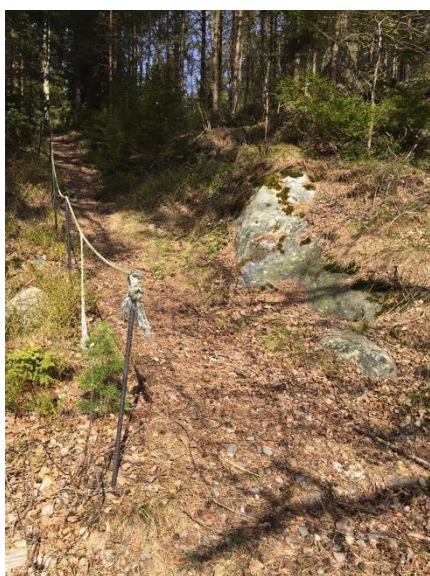
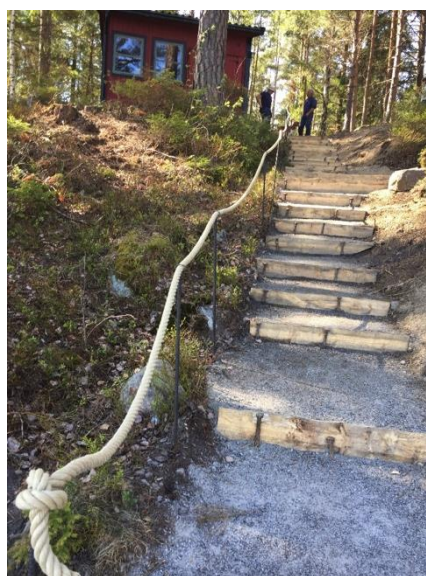
The seal station is set in an isolated location by a cove in Stockholm's southern archipelago. The terrain is steep and inaccessible, and so to make it safe to walk in the area, the military constructed simple steps in the countryside with half logs and gravelled risers. Over the years, these steps have fallen into decay and more or less crumbled away. We restored the steps on the basis of instructions and guidance from the historian. The original pins that held the logs in place were reused in their original positions. We also reused the metal holders for the guide ropes, but the ropes themselves had to be replaced with new ones.

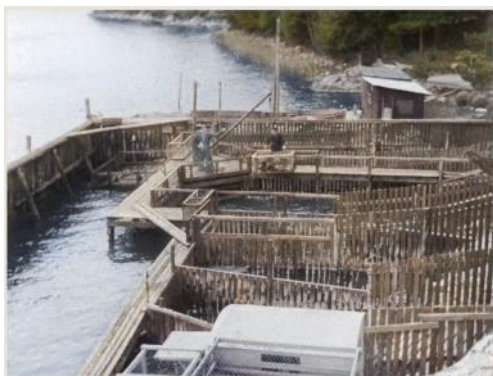
The seal pool was home to the seals when they were not at sea on training exercises. There were partitions to separate the different groups of seals. Only remains of these partitions were to be found at the bottom of the seal pool.

On the southern jetty, there was also a crane that was used to hoist the seals into a cage for transfer to the transport barge *Palmen*, which moored on the other side of the jetty.

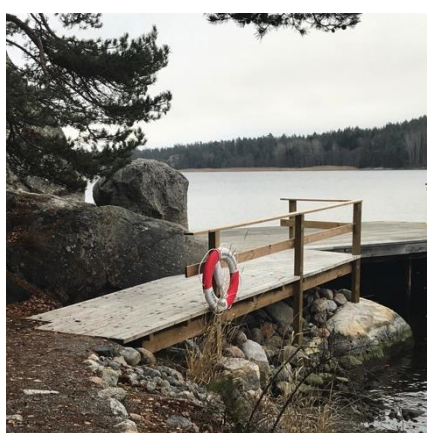
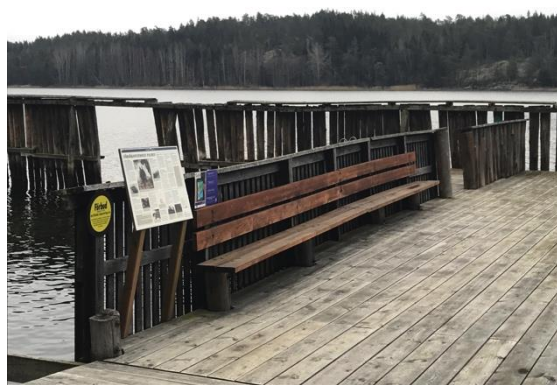
An exploratory dive revealed that the stockade and jetties are still in relatively good condition. According to *Skärgårdsstiftelsen*'s former supervisor, parts of the stockade were replaced in the 1970s. For financial reasons, we chose not to work on the stockade and the jetties within the framework of this project.

Instead, we built a new gangway to the northern jetty as a replacement for the old one, which was on the point of collapsing into the sea.

The long bench on the southern jetty was also replaced. It probably dates from the period after the end of Operation *Palmen*, but we chose to restore it because it adds value for visitors.

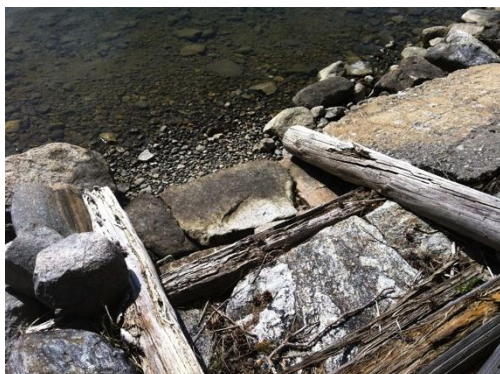
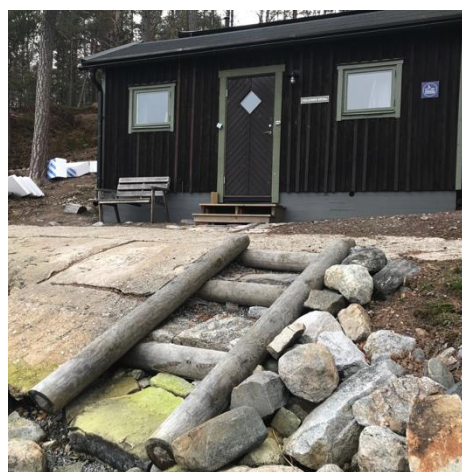
The seal basin also contains an old flight of steps built of horizontally laid stones and split logs. We were unable to establish precisely what the steps were used for, but it is likely the facility simply needed an easy way to enter the water from the edge of the pool. The stone sections were intact and did not need any work, but the logs had to be replaced. The top of the steps is not flush with sea level today, due to the fact that the land has risen approx. 25–30 cm since 1940.

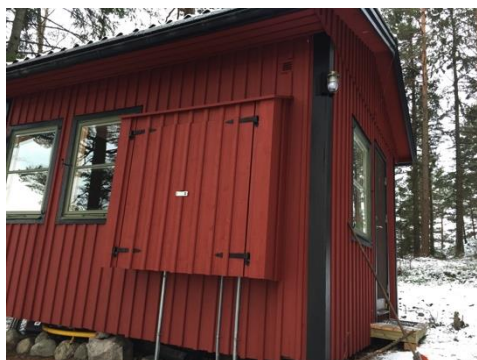
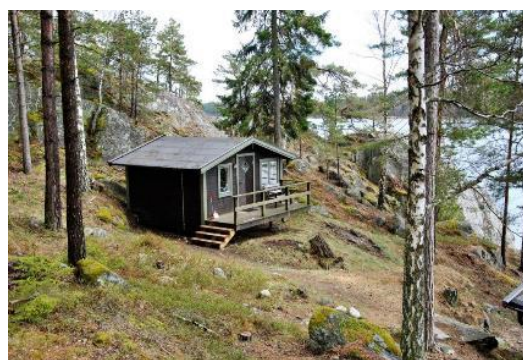
The newer buildings have no cultural or historical value, and do not make any contribution to understanding the history of the site. These buildings have simply been painted, and a small area of damage to one of the roofs has been repaired.
